PRELIMINARY
KNKT.12.05.09.04

Aircraft Accident Investigation Report

Sukhoi Civil Aircraft Company
Sukhoi RRJ-95B; 97004
Mount Salak, West Java
Republic of Indonesia
9 May 2012

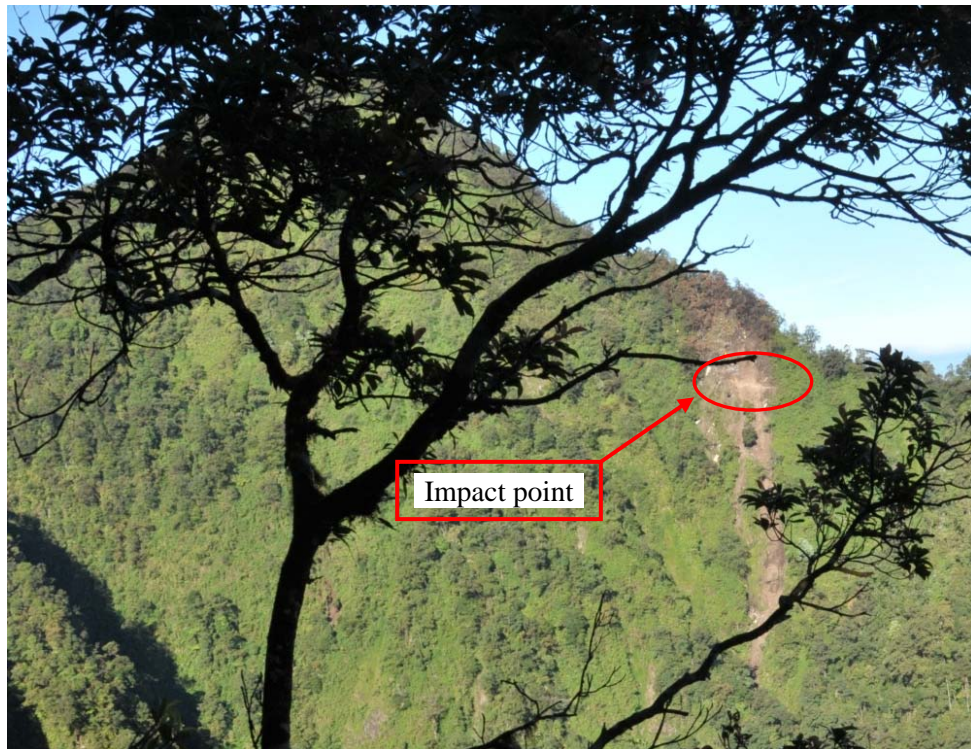
The aircraft was impacted at 6,000 feet (according to BASARNAS report) to an approximately 85 degree slope ridge. The wreckages were spread in wide area. Most of the wreckage such as landing gear, engine and vertical stabilizer were found at the bottom of the valley at approximately 500 meters below the impact point.

The area surrounding the impact point was found burnt. Some wreckage on that area was found partially burnt.

The aircraft was destroyed by impact forces and post impact fire.

Figure 4: The ridge facing to the east

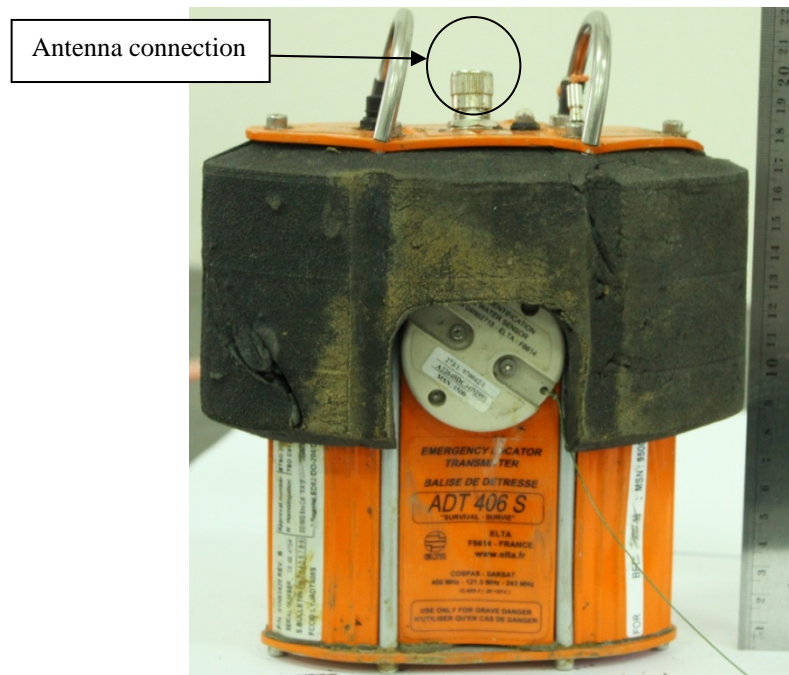
No distress signal was received by BASARNAS, Australian RCC (Rescue Coordinator Centre), Singapore RCC, and Malaysia RCC.

The ELT was found with antenna detached.

Figure 5: Emergency Locator Transmitter with antenna detached.
